Introduction:

A factory flaw was brought to light due to a critical incident that had occurred when an Arizona DPS State Trooper attempted to discharge his issued FN model FNS pistol in the line of duty. During the altercation, the muzzle of the trooper's firearm was pressed against the torso of a combative subject when he pulled the trigger. By design the semiautomatic pistol will not fire when the slide is out of battery. However, while using one of our reference collection FN model FNS 40 pistols to show the investigators the trooper's firearm did not malfunction, it was determined the trigger was not resetting completely (Images 1-3). When the pistol was placed on the table top, its striker could be heard releasing forward. This raised the question of whether the pistol would fire a chambered cartridge without having your finger on the trigger.

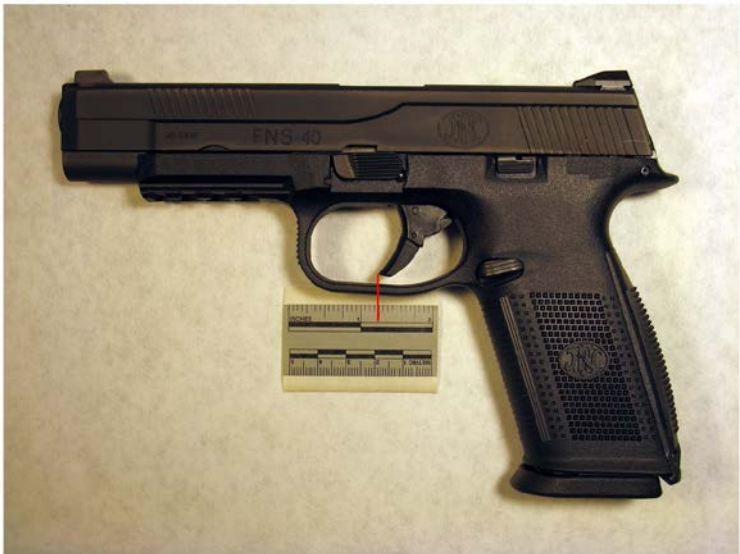
Image 1: Trigger in its forwardmost reset position.

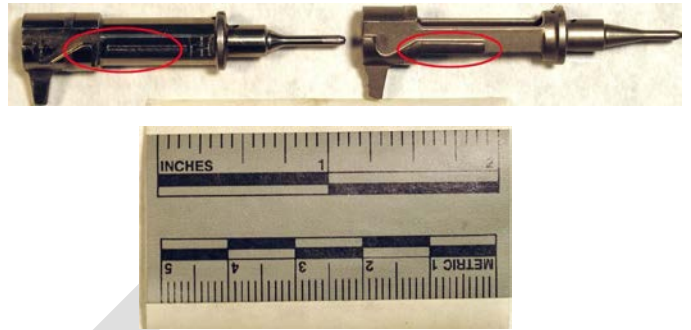
It was determined after disassembling the pistols that due to its design the striker would remain in the "cocked" position, held back by the striker block (Images 7-9). This was caused by a machined notch on the side of the striker. In this condition, with the trigger not reset, the only part retaining the striker in

this “cocked” position was the striker block. When the slide was tapped with a mallet or the firearm jarred at all it would cause the notch on the striker to bypass the striker block and fire the pistol.

Image 10: FNS faulty strike r o n the left and the replacement model 509 strike r o n the right. Note the machined notch on the faulty strike r that makes contact with the striker block.

FN was contacted, and after showing video footage of both scenarios they quickly provided the installation of replacement parts to correct the defective parts in the department’s duty weapons as well as personal weapons purchased by DPS personnel. The corrective action was to replace the strikers from affected pistols to the new FN model 509 type striker. The machined notch that was present on the FNS models was no longer present on the model 509 strikers (Image 10). Similar testing was conducted using the new strikers and it was found to have corrected the problem.

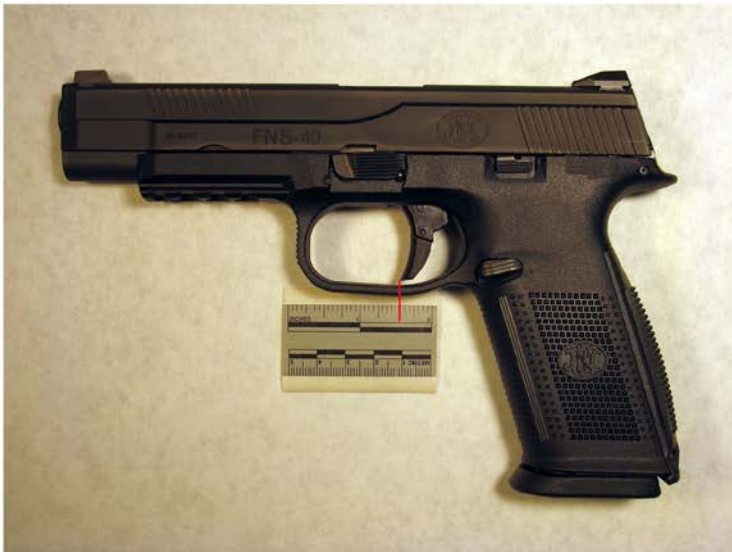
A primed cartridge case was hand chambered into a FNS 40 long slide from our reference collection. The muzzle of the pistol was placed against the rubber backstop in our shooting range. This caused the slide to go out of battery by approximately one eighth of an inch. The trigger was pulled to the rear and this time released. The striker did not release forward at this point; however, it was obvious that the trigger was not resetting to its forward most position. The muzzle was pulled away from the backstop and the pistol did not fire at this point. With the shooter's finger still off the trigger a small gunsmithing mallet was then used to lightly tap on the top of the slide which caused the striker to release forward and detonate the primer (Image 6). This scenario was tested multiple times with all versions of the FNS model and consistently fired a primed cartridge case. This scenario was also tested using live ammunition and a fully loaded magazine with the same results. Testing was done by tapping the side of the slide, the back of the slide, and even the bottom of the magazine with similar results, however, the pistol would fire less consistently when tapping on the bottom of the magazine. As a reminder, nothing was contacting the trigger of the pistol when it would fire during scenario two. In some instances, just placing the firearm back into its holster after removing the muzzle from the backstop would cause the striker to release forward and fire the primed cartridge case.

Image 2: Failure to reset after slide was placed out of battery and trigger pulled

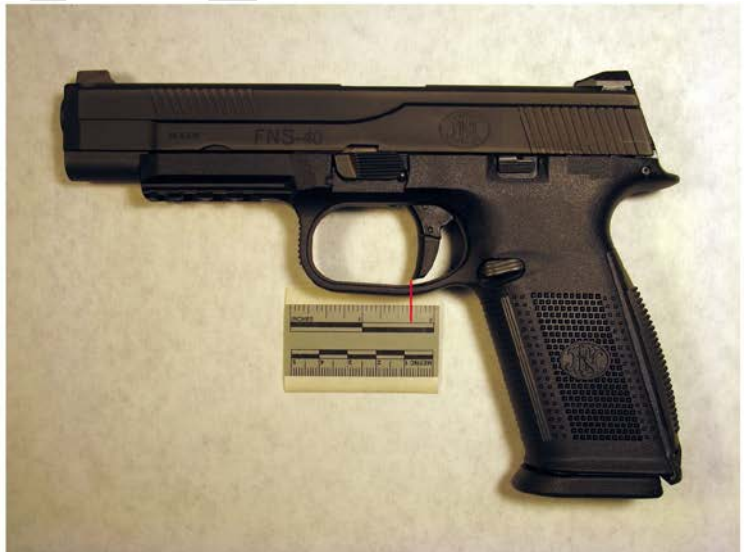
Image 3: Trigger fully pressed to rear after releasing striker

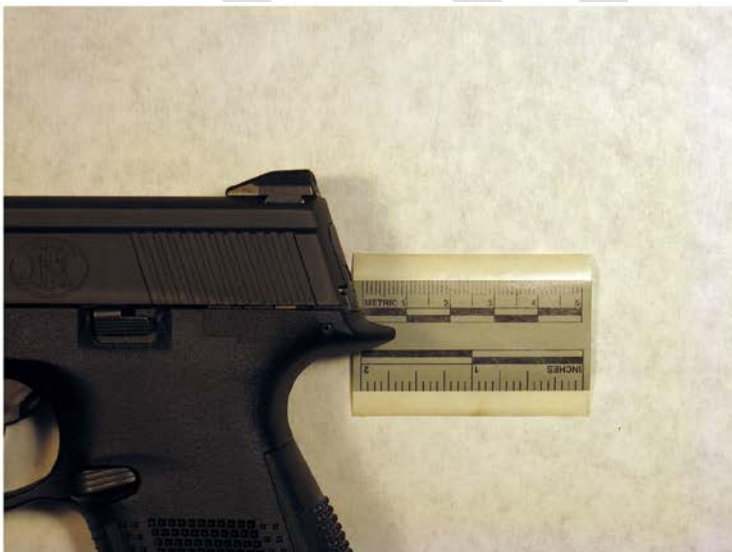
A primed cartridge case was hand chambered into a FNS 40 long slide from our reference collection. The muzzle of the pistol was placed against the rubber backstop in our shooting range. This caused the slide to go out of battery by approximately one eighth of an inch (Images 4-5). The trigger was pulled and held to the rear. The striker did not release forward at this point. The muzzle was then pulled away from the backstop while the trigger remained pressed and the striker released causing the primed cartridge case to fire. This scenario was tested multiple times with all versions of the FNS model and consistently fired a primed cartridge case. This scenario was also tested using live ammunition and a fully loaded magazine with the same results. Each time the pistol would fire when the muzzle was pulled away from the backstop and the trigger remained pressed to the rear.

Image 4: Slide fully forward and in battery

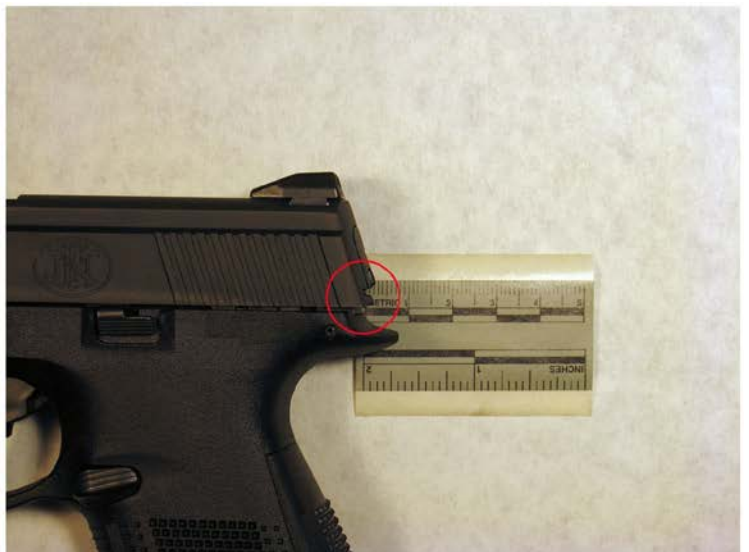
Image 5: Slide moved back out of battery

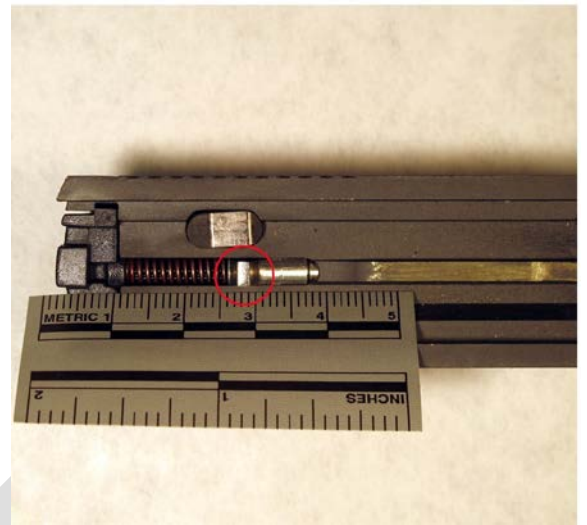
Image 7: S triker block holding the faulty st riker on the first notc h

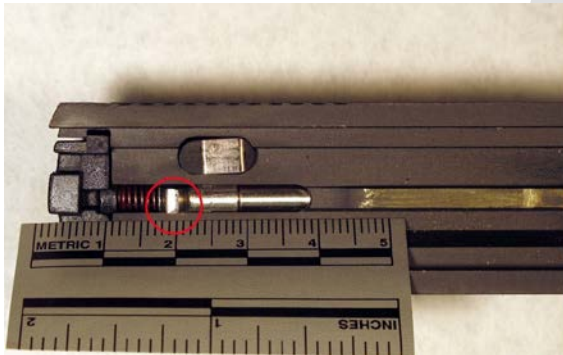
Image 8: Striker block holding the faulty striker on the second machined notch

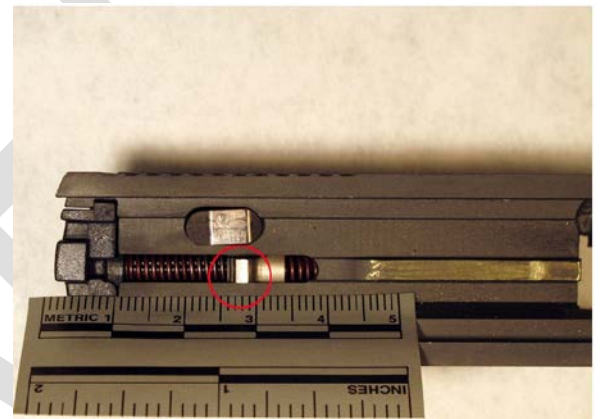
Image 9: Striker block holding the replacement 509 striker on the first and only notch
